# Resistance to Fracture, Fatigue and Stress-Corrosion of Al-Cu-Li-Zr Alloys

A. K. Vasudevan, R. C. Malcolm,  
W. G. Fricke, and R. J. Rioja

Aluminum Company of America  
Alcoa Laboratories  
Alcoa Center, PA 15069

Final Report  
(Period: 1981 July 01 to 1985 February 28)  
Contract N00019-80-C-0569  
Department of the Navy  
Naval Air Systems Command  
Washington, D.C. 20361

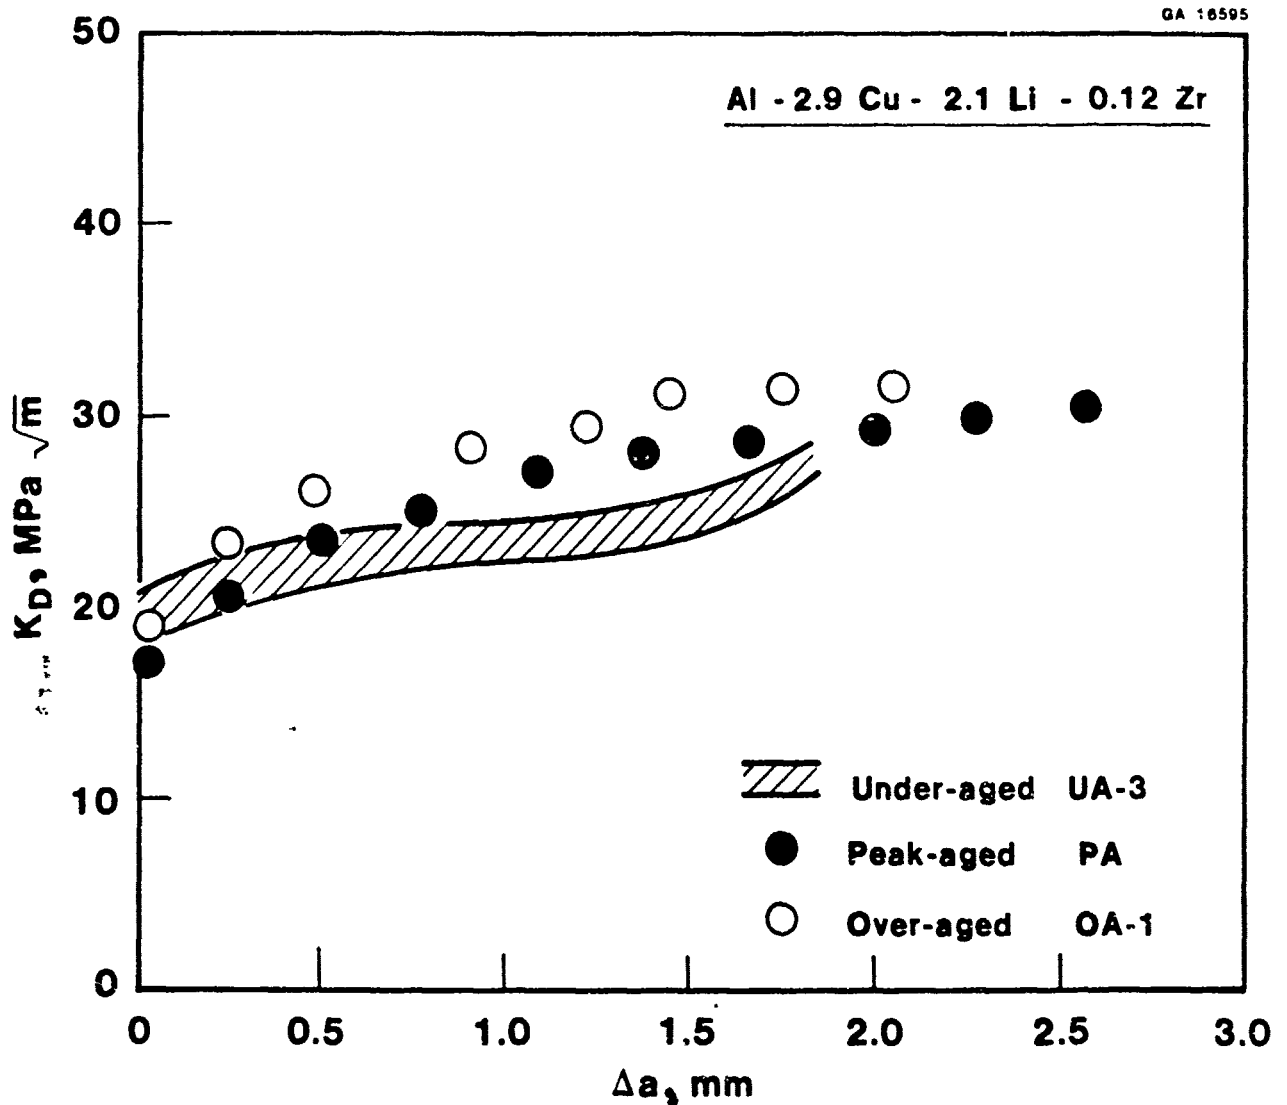
**Variation of Deflection-Modified Effective Stress-Intensity Factor,  $K_D$ , with Change in Crack Length,  $\Delta a$ , (modified R-Curve) for UA-3, PA and OA-1 Tempers**

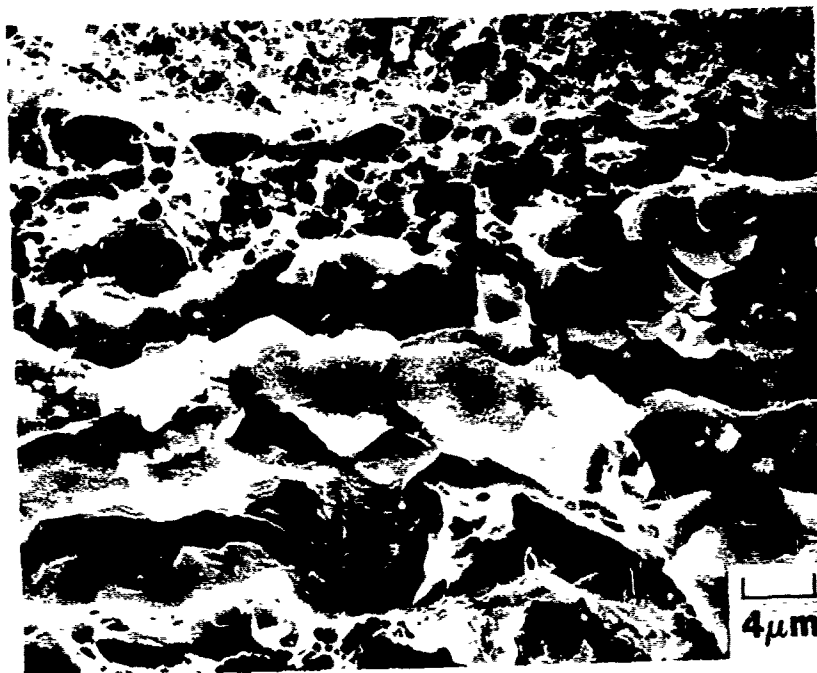
(a) SEM fractograph of a static fracture surface of a fracture toughness specimen from TMP 2020 plate sample 523713-X (peak aged)

(b) SEM fractograph of fracture surface within circled area shown in (a)

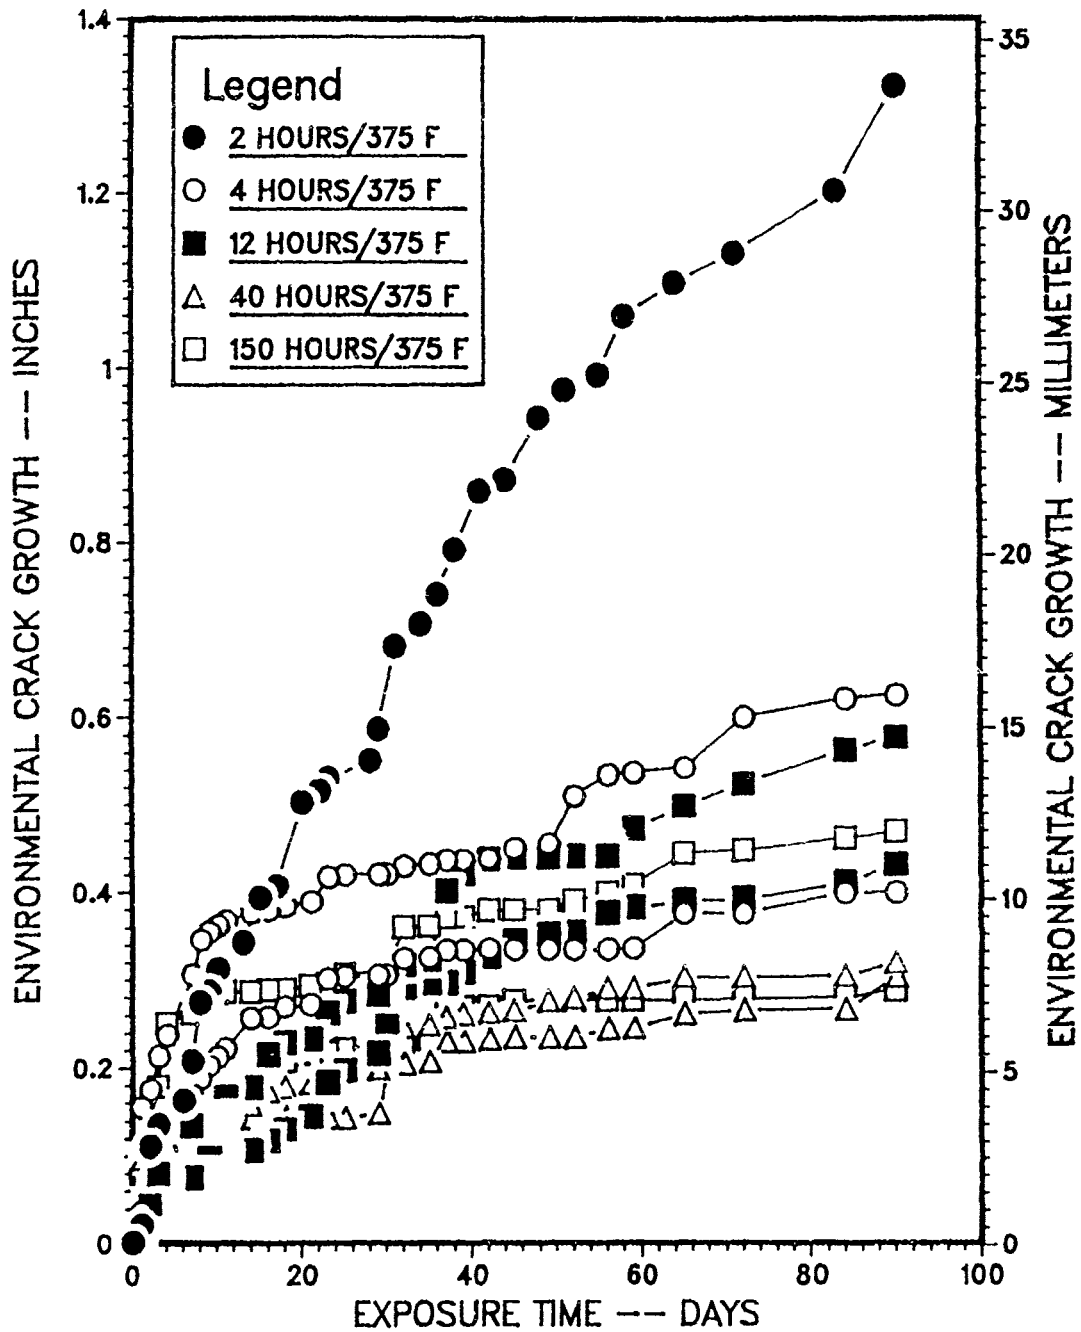
Figure 74

Crack growth vs. exposure time data for various aging treatments of sample 548466 (Al-2.9Cu-2.1Li-0.12Zr alloy)

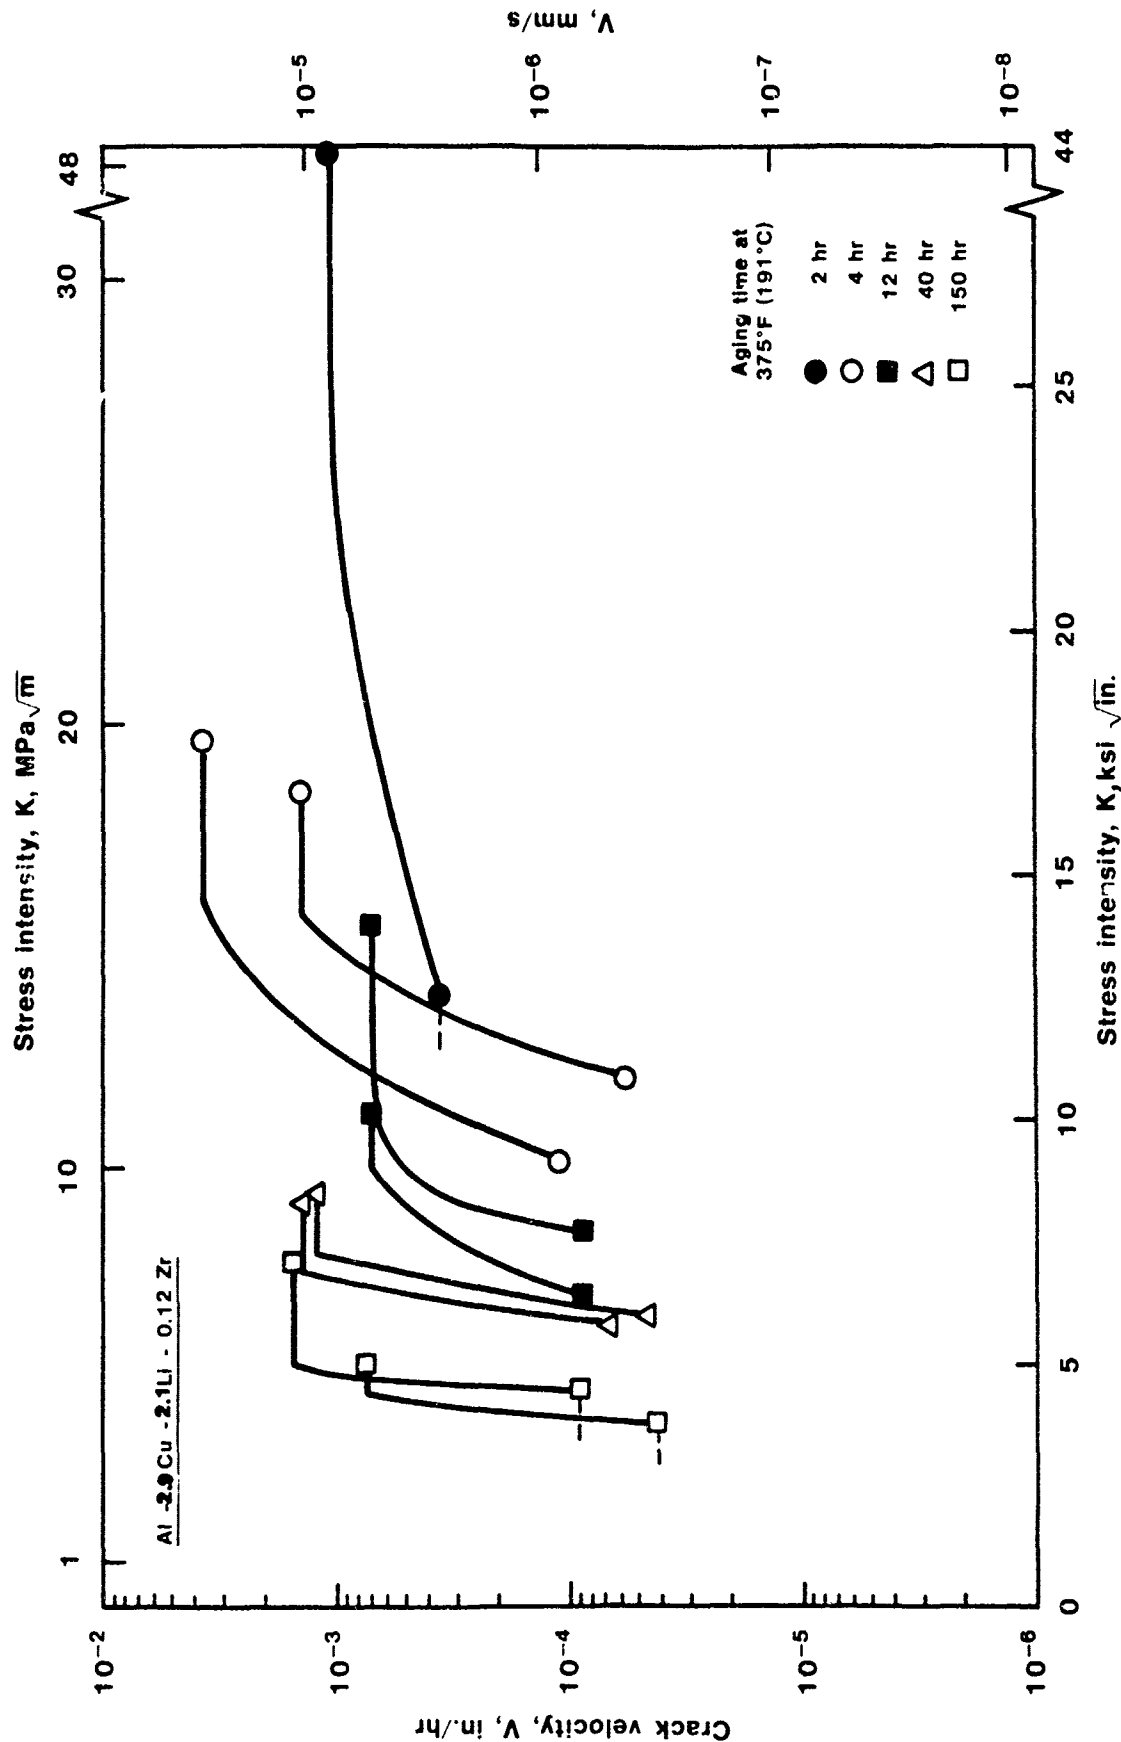
**SCC Velocity vs. Stress Intensity Data  
for Sample 548466 at Various Aging Conditions**

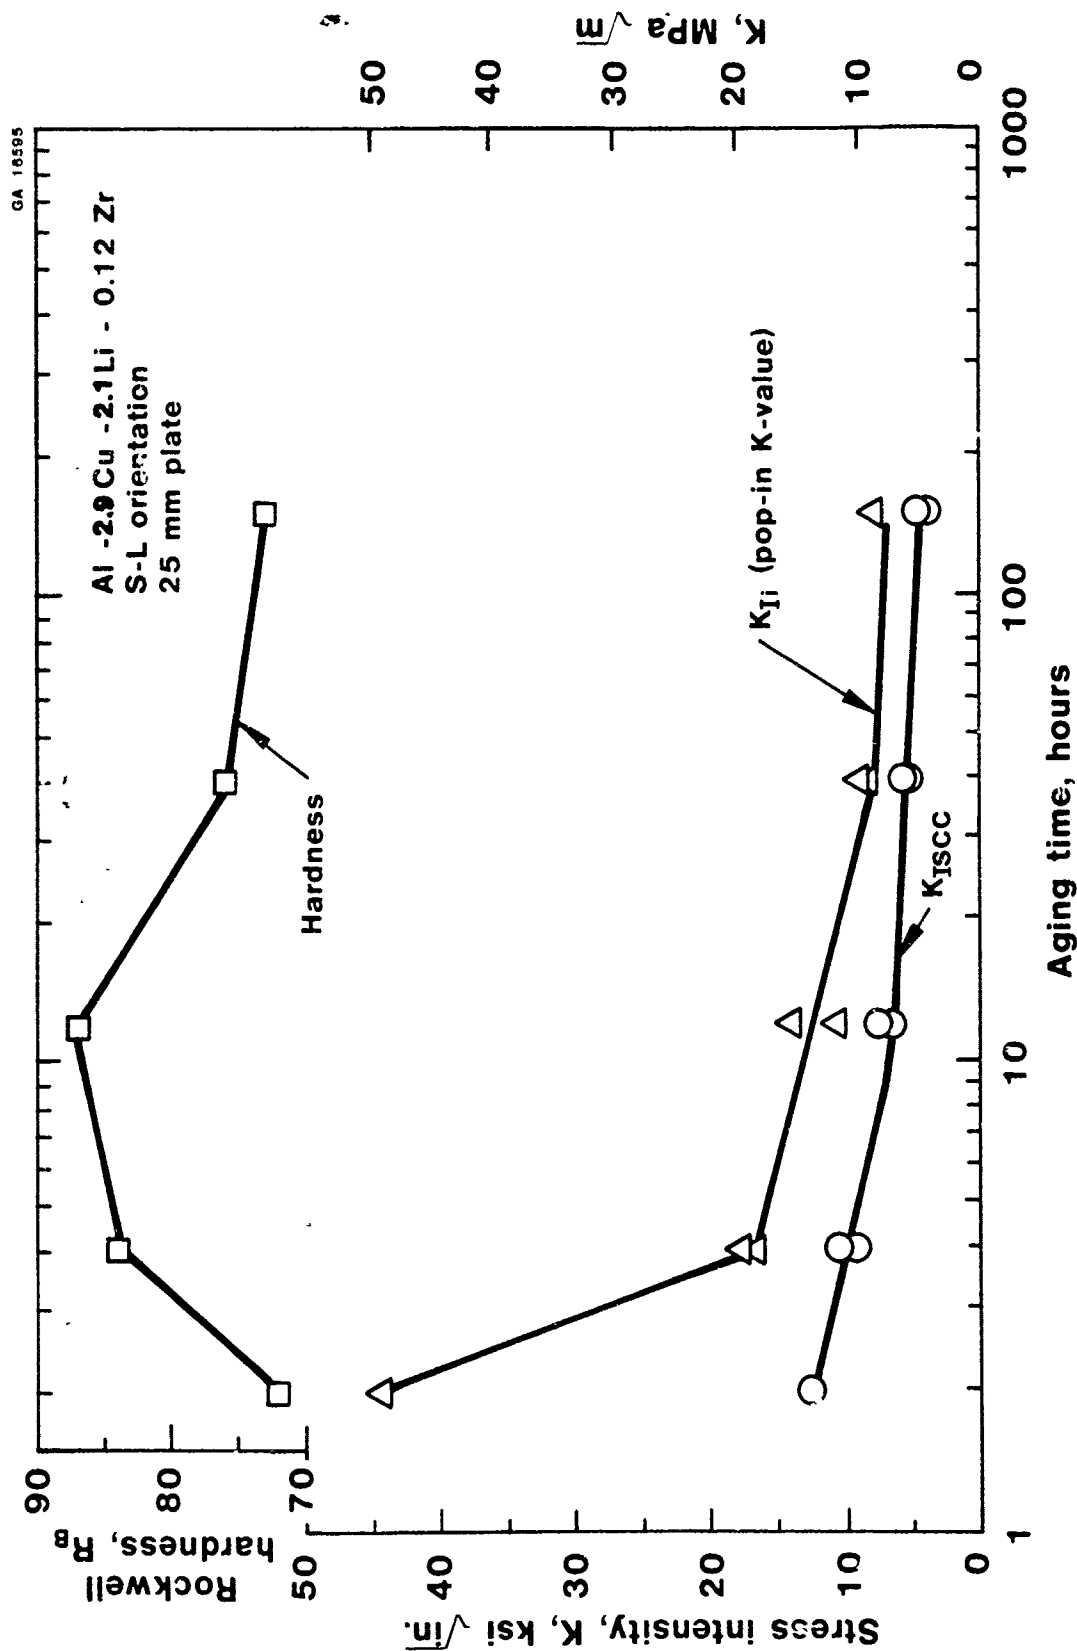
Variation of Hardness,  $K_{IjSCC}$  and  $K_{Iji}$   
with Aging Time at 375°F (191°C)

Average environmental crack growth for various S-L DCB specimens removed from various thickness plates and exposed to 3.5% NaCl solution dropwise for 30 days

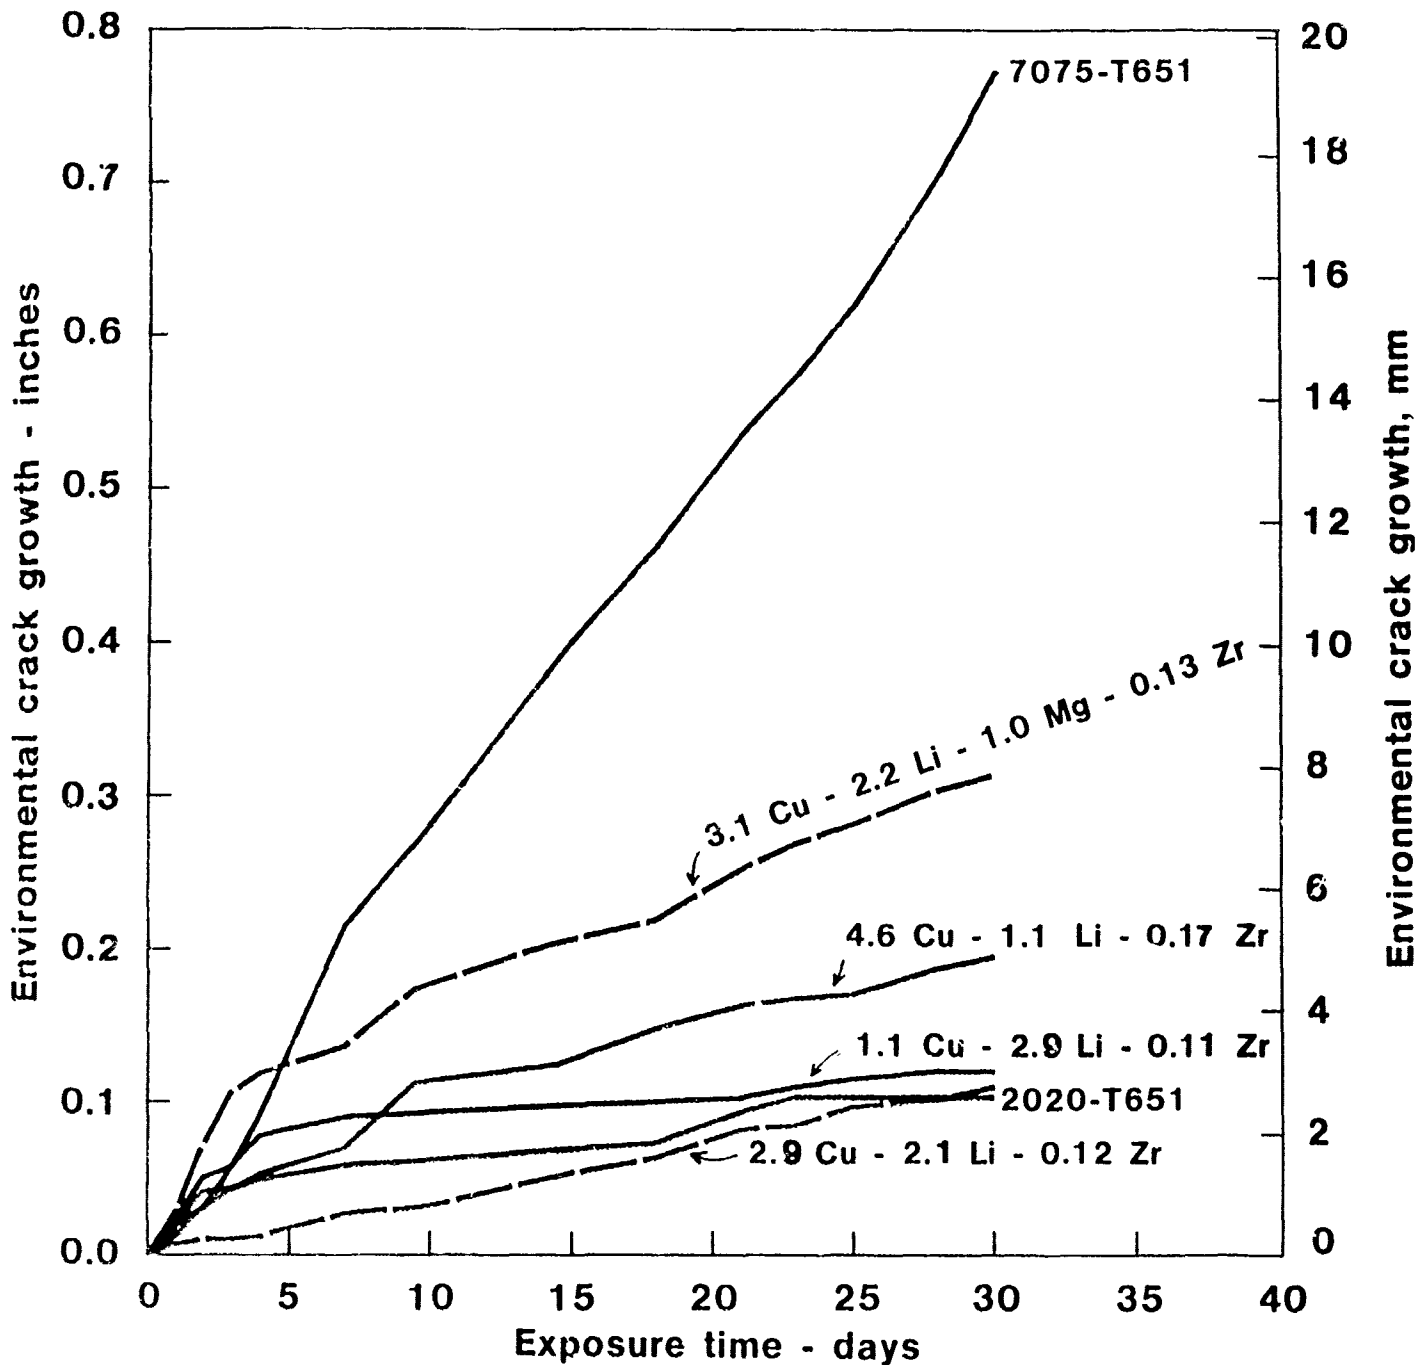
Crack Growth vs. Exposure Time Data for Various Compositions of Al-Cu-Li-Zr Alloys

Estimated K-rate curves for various alloy specimens removed from various thickness plates and exposed to 3.5% NaCl solution dropwise for 30 days

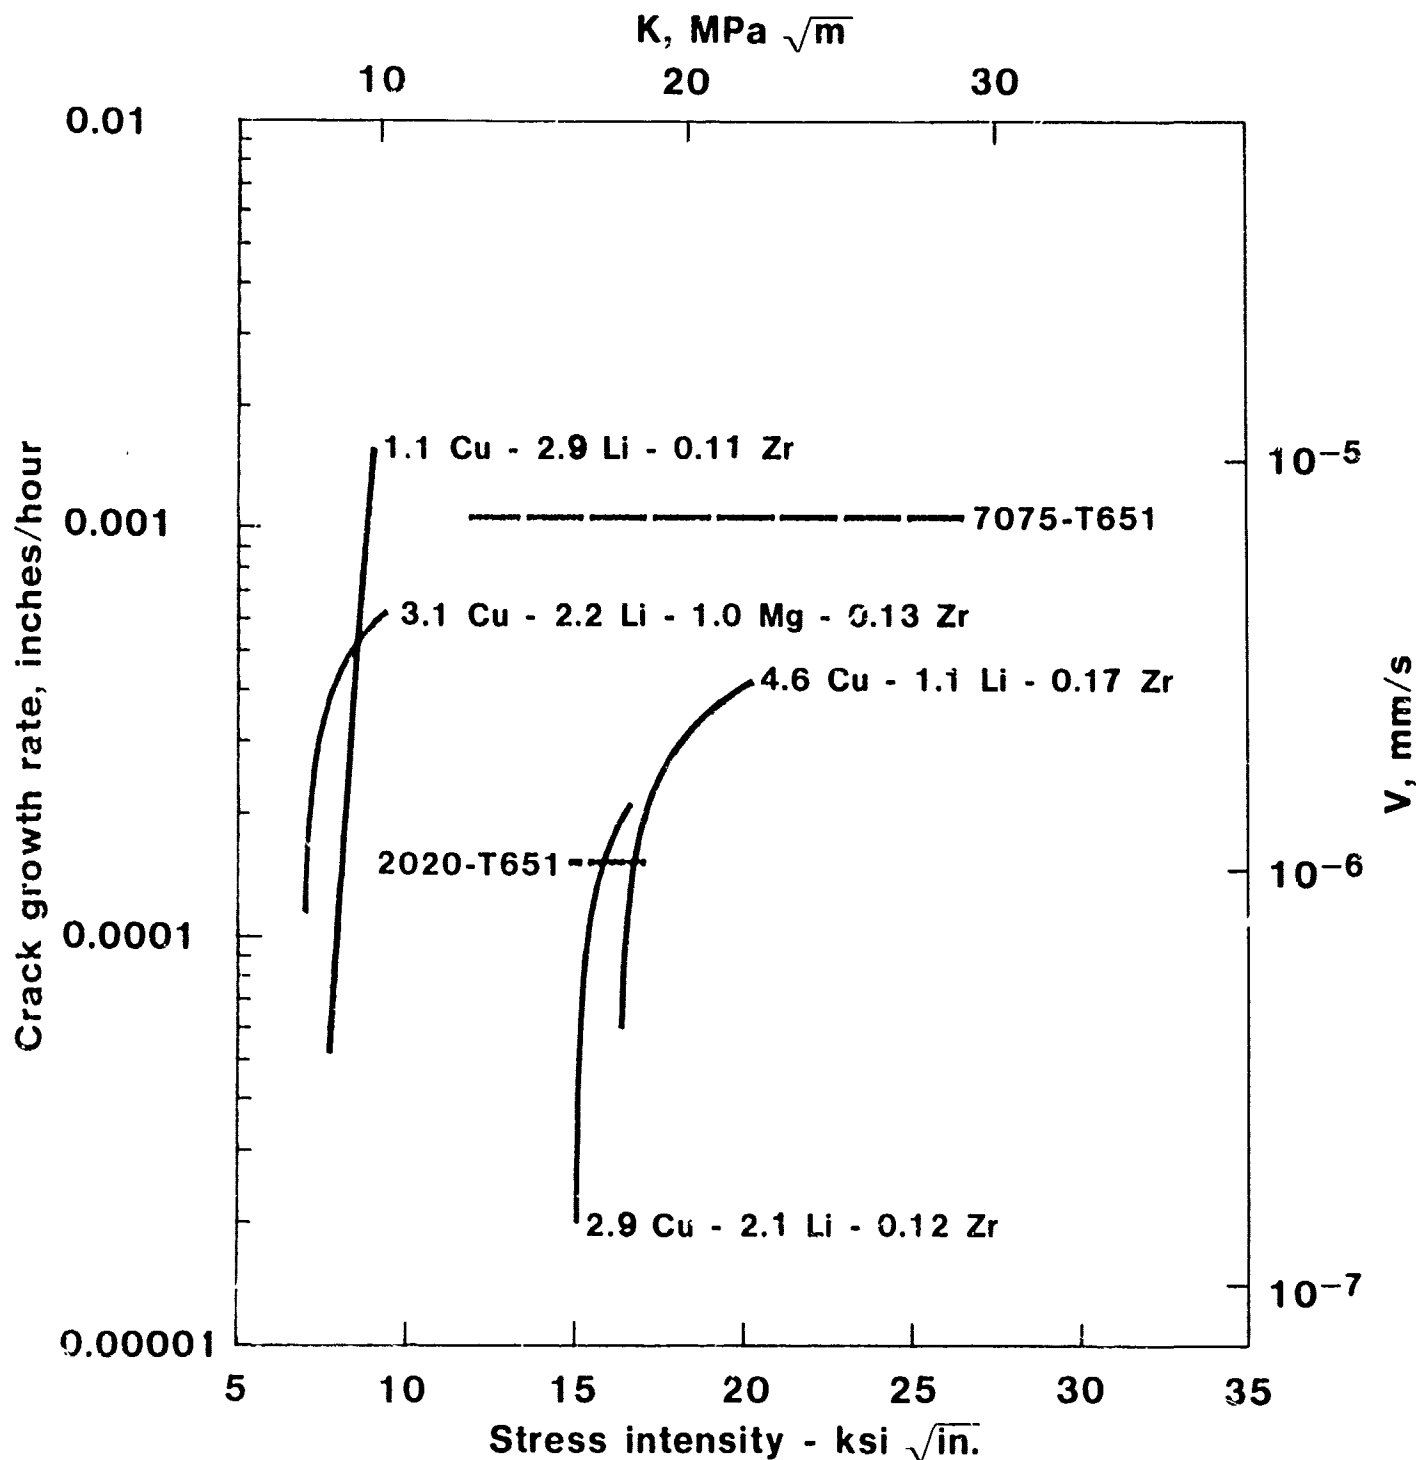
SCC Velocity vs. Stress Intensity Data for Various Compositions of Al-Cu-Li-Zr Alloys

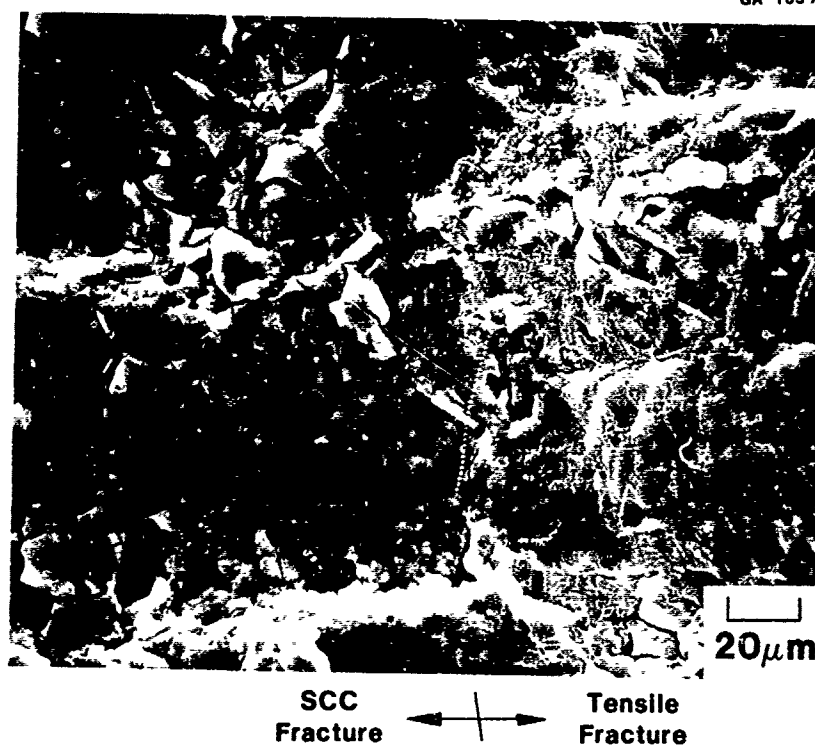
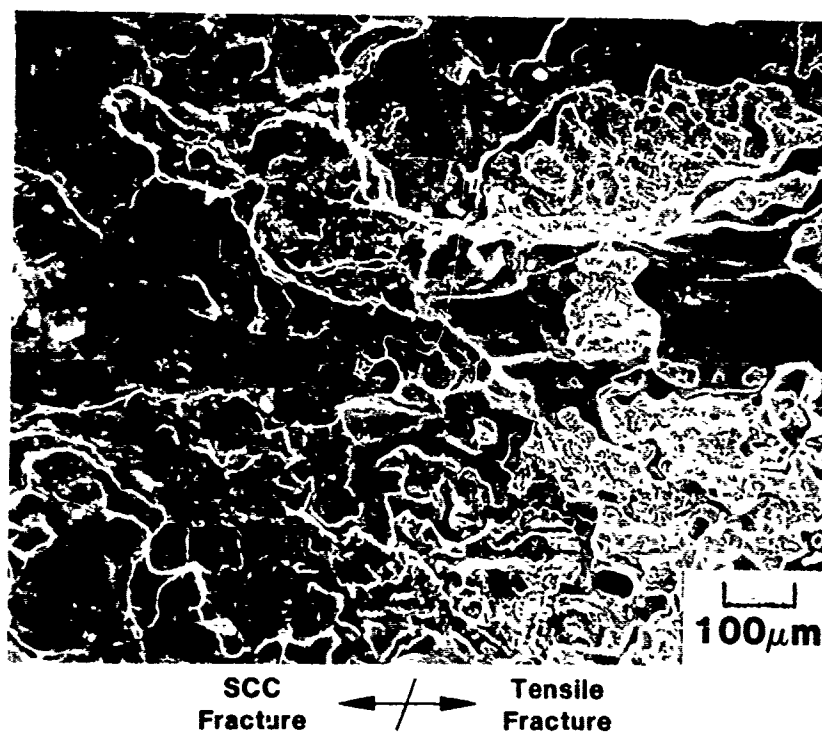
Figure 79

(a) SEM fractograph of a fracture surface of a DCB SCC specimen from sample 548465 (Al - 4.6 Cu - 1.1 Li alloy T651 plate)

(b) SEM fractograph of a fracture surface of a DCB SCC specimen from alloy 2020-T651 plate

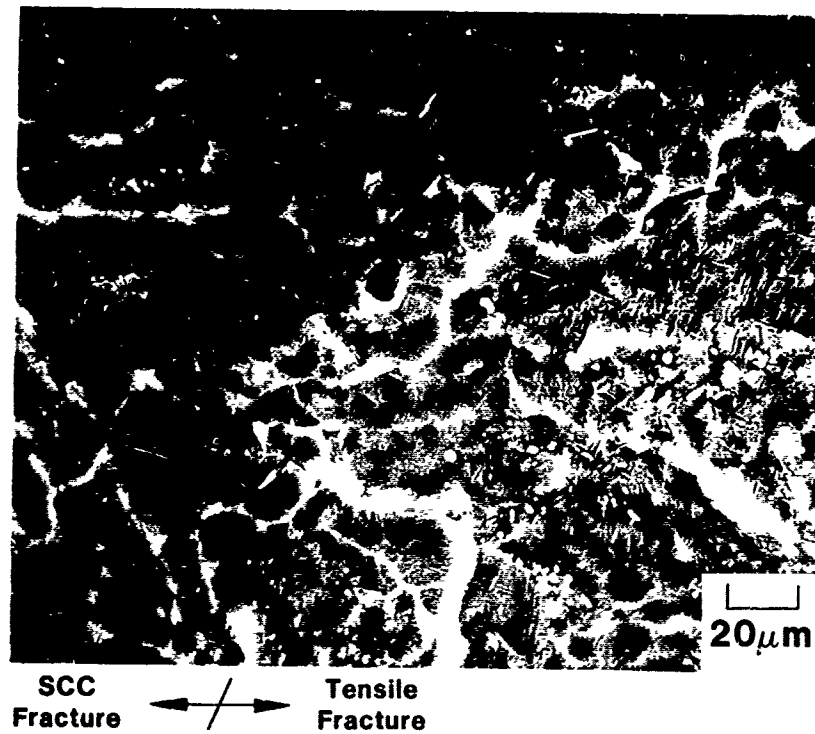
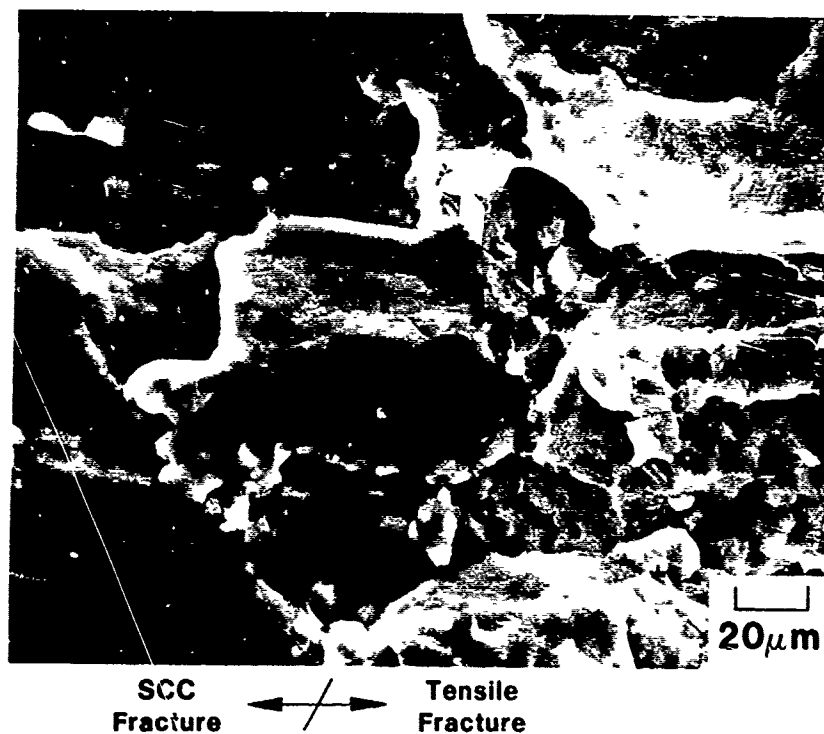
(a) SEM fractograph of a fracture surface of a DCB SCC specimen from sample 548466 (Al -2.9Cu-2.1Li alloy T651 plate)

(b) SEM fractograph of a fracture surface of a DCB SCC specimen from sample 504440 (Al -3.1Cu-2.2Li - 1 Mg alloy T651 plate)

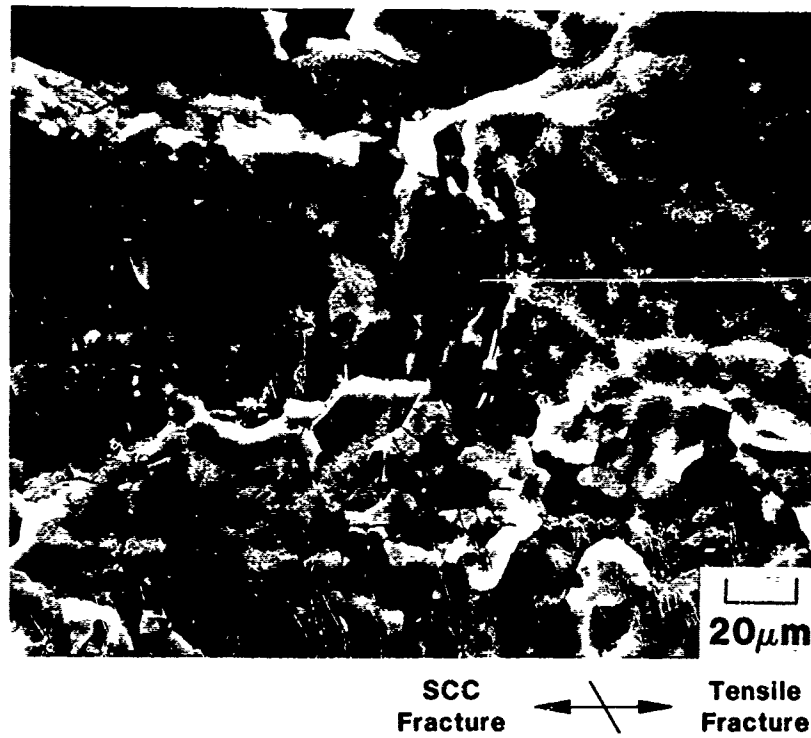
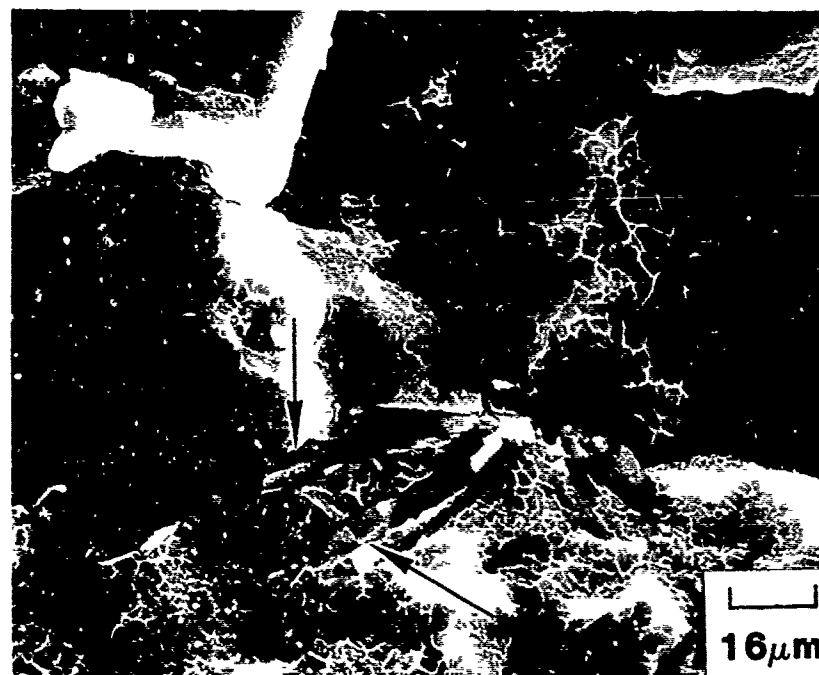
(a) SEM fractograph of a fracture surface of a DCB SCC specimen from sample 548468 (Al -1.1Cu-2.9Li alloy T651 plate)

(b) SEM fractograph of tensile fracture surface of specimen referenced in (a)

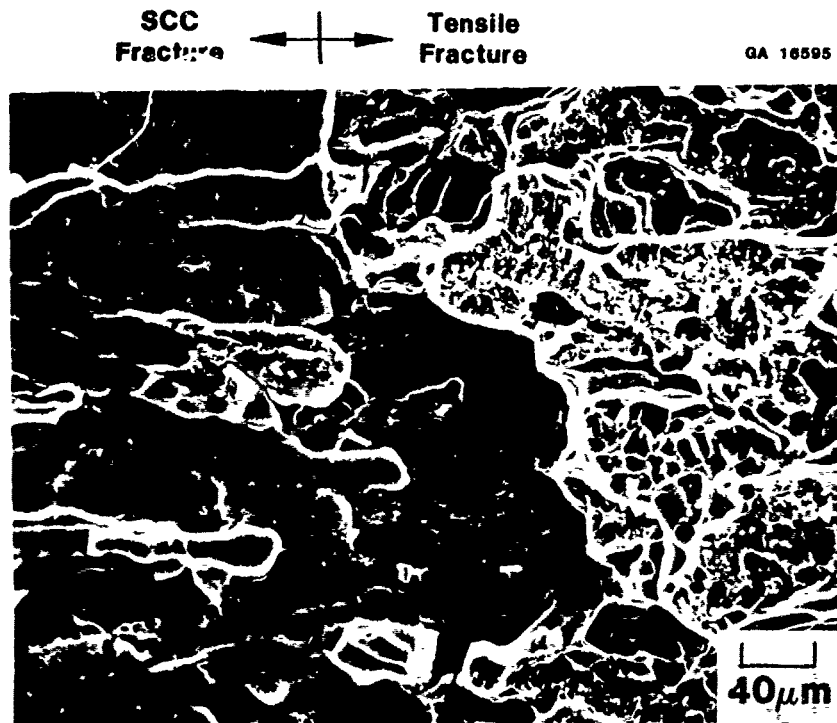
SEM fractograph of a fracture surface of a DCB SCC specimen from alloy 7075-T651 plate

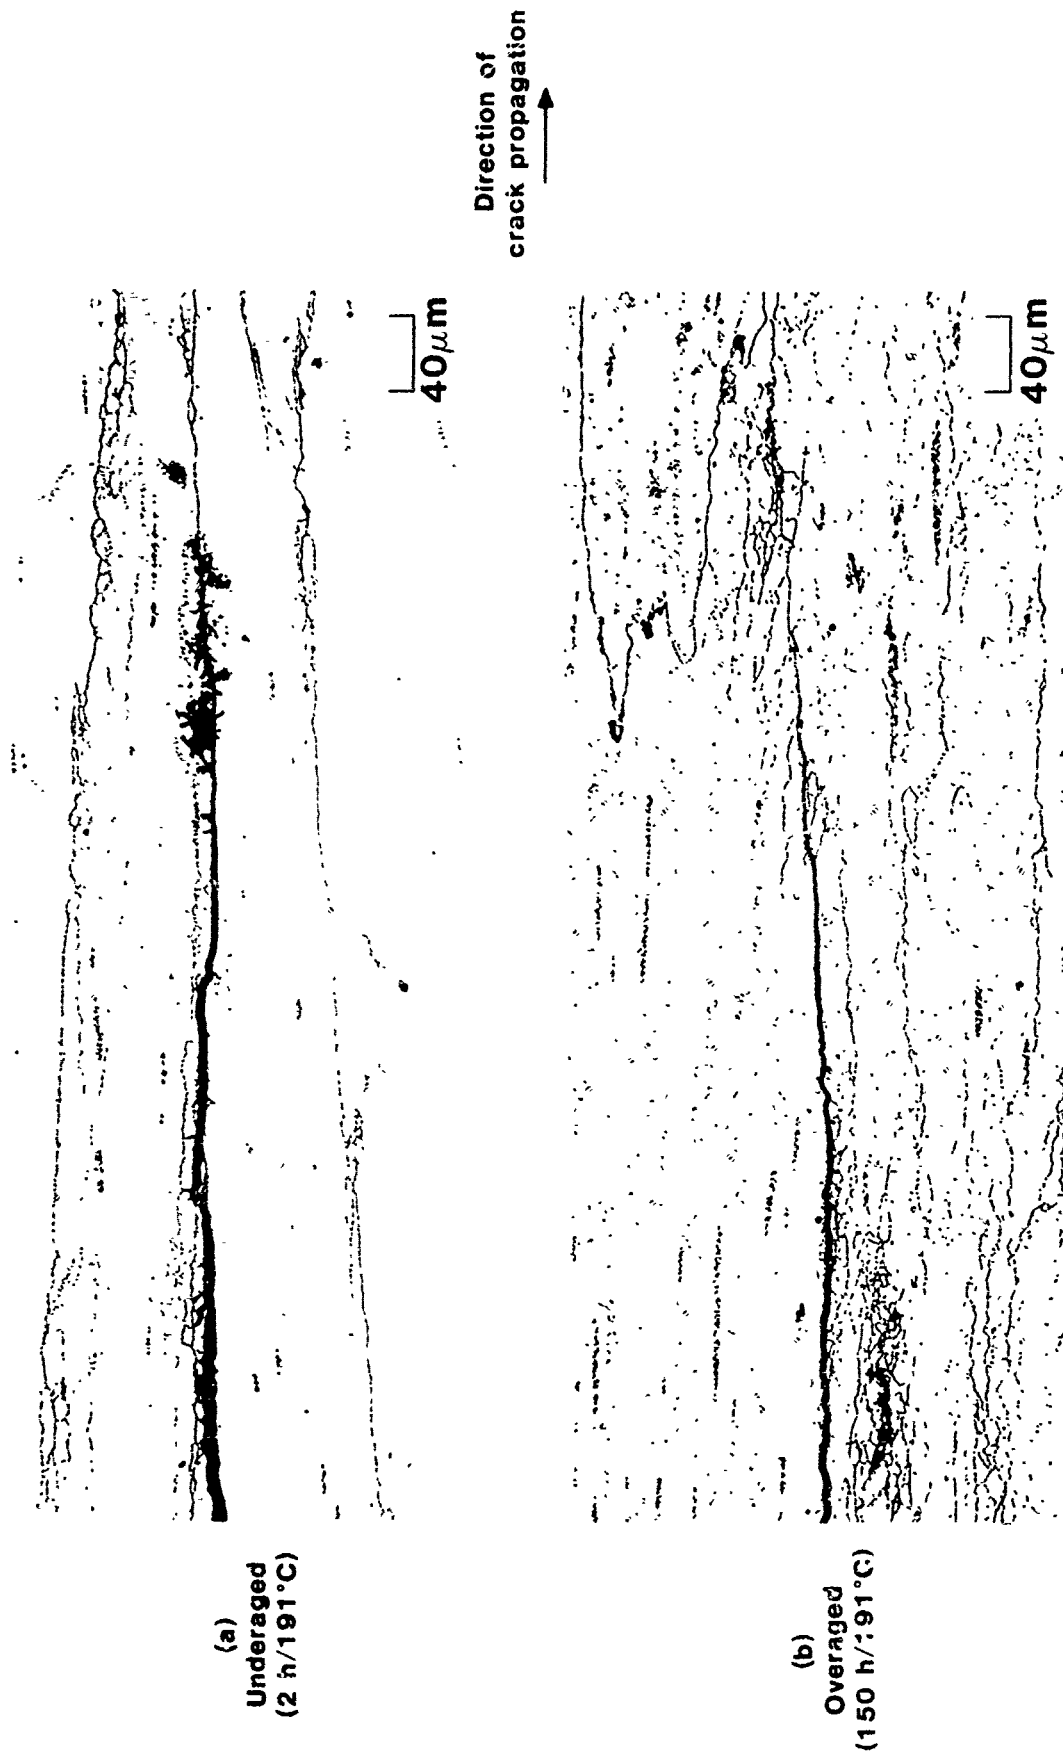
Photomicrographs of tip of the crack in DCB SCC specimens from underaged (a) and overaged (b) sample 548466 (Al -2.9Cu -2.1Li alloy T651 plate)

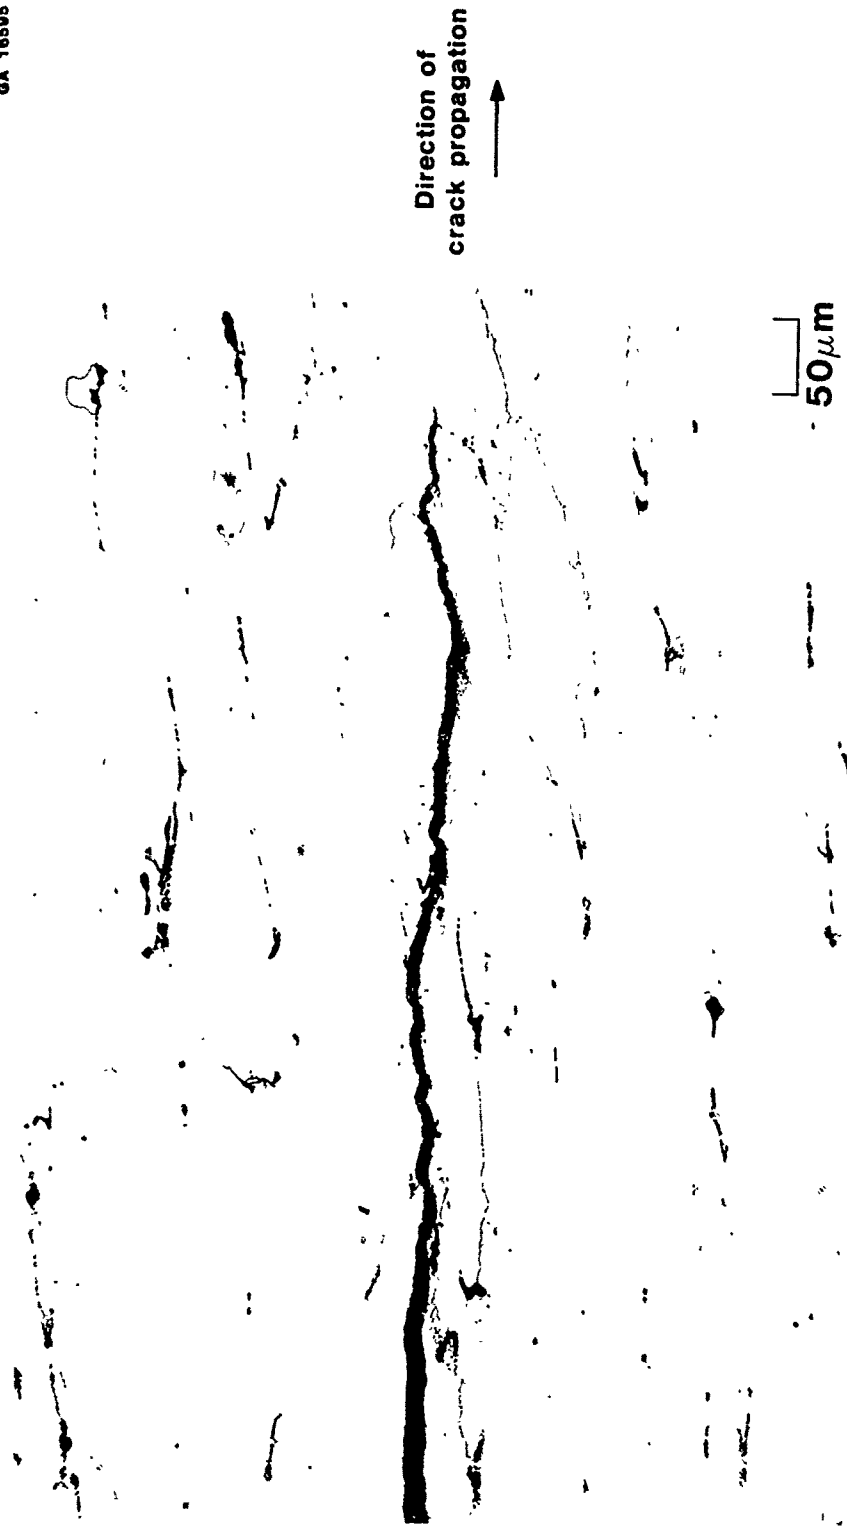
Photomicrograph of tip of the crack in DCB SCC specimen from sample 504412 (7075-T651 plate)

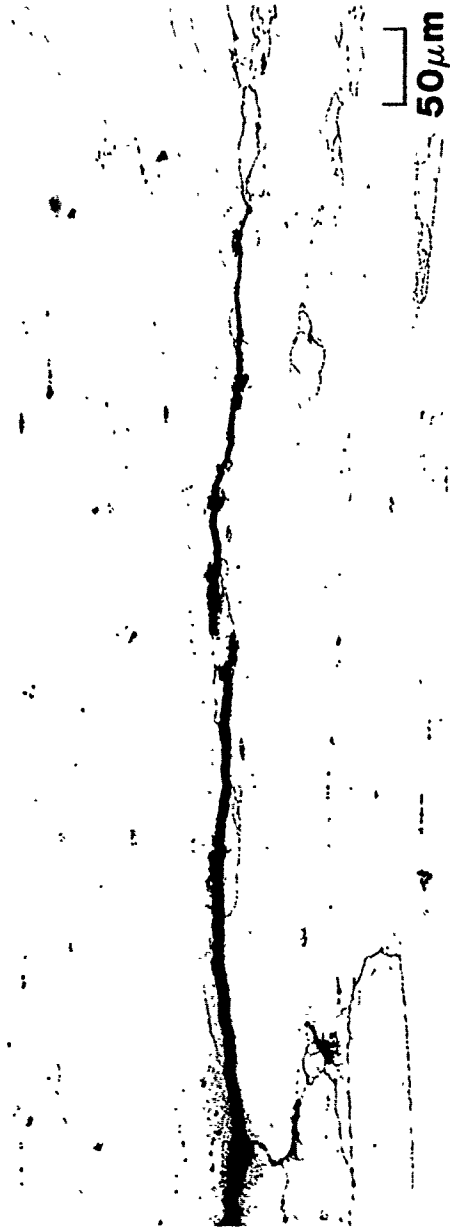
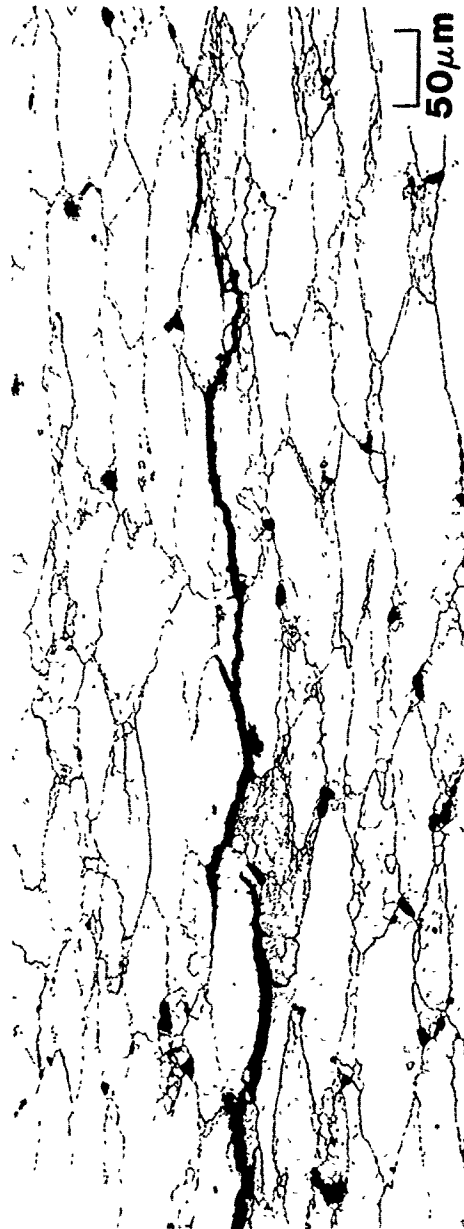
Photomicrographs of tip of the crack in DCB SCC specimens from samples 548466 (a) and 504440 (b) (Al -2.9Cu -2.1Li and Al -3.1Cu -2.2Li - 1 Mg alloys, respectively, T651 plate)

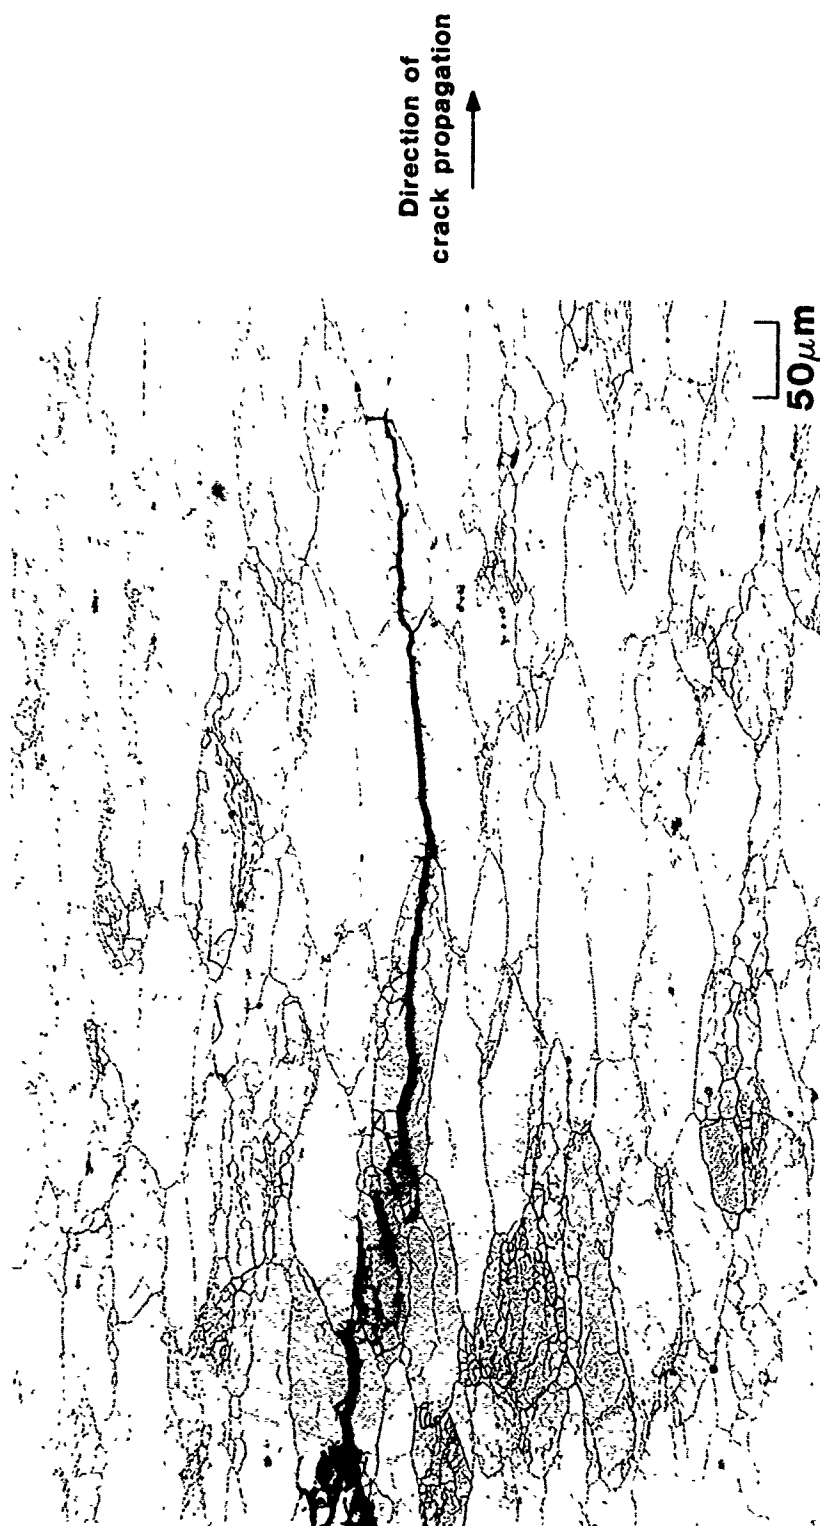
Photomicrograph of tip of the crack in DCB SCC specimen from sample 548468  
(Al -1.1Cu -2.9Li alloy T651 plate)

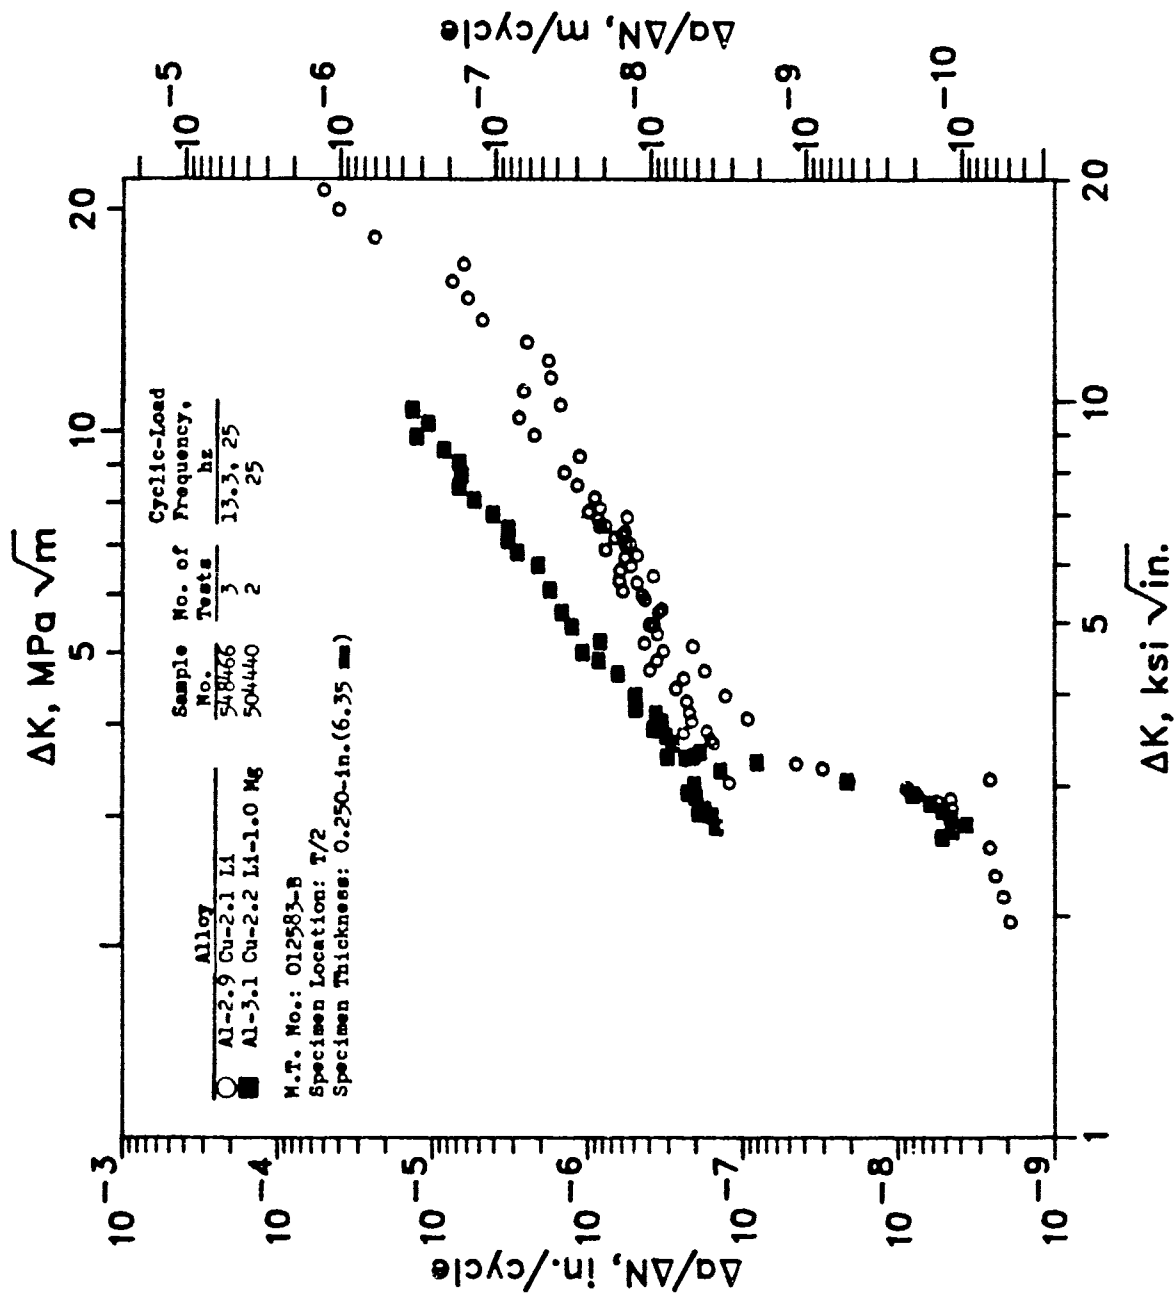
Comparison of Constant-Load-Amplitude Fatigue Crack Growth Data for Laboratory Fabricated Aluminum Alloys (2.9 Cu - 2.1 Li) - T651 and (3.1 Cu - 2.2 Li - 1.0 Mg) - T651 Plate, 0.5-in. (12.7 mm) thick L-T orientation, R-Ratio = +0.33, High Humidity (R.H.>90%) Air
